A. Shanyavskiy et alii, Frattura ed Integrità Strutturale, 37 (2016) 22-27; DOI: 10.3221/IGF-ESIS.37.04

Multiaxial fatigue of in-service aluminium longerons for helicopter rotor-blades

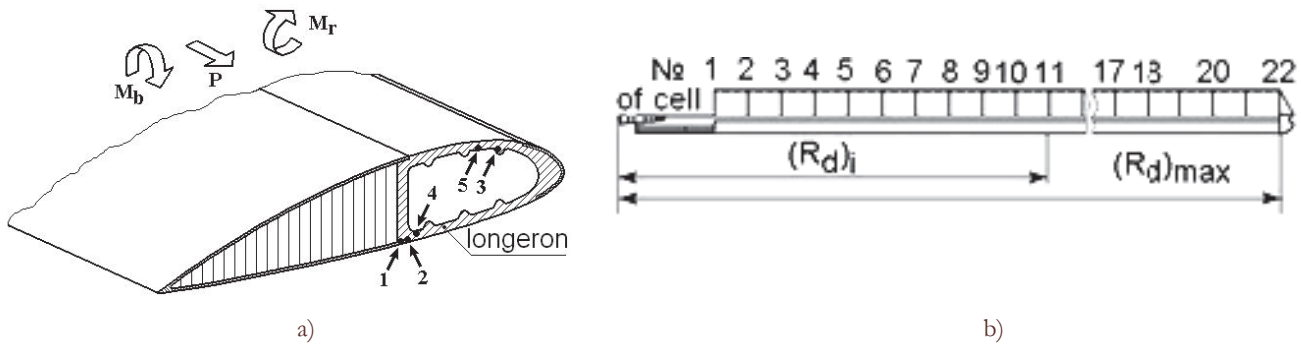
Figure 1: Scheme (a) of rotor-blade section with numbering “1”-“5” areas for crack origination and pointed out its external loading and (b) cells position for a blade.

In-service fatigue cracks nucleated in the longerons in the defect sites that were revealed all over the blade length, from $\bar{R} = 0.085$ to $\bar{R} = 0.71$, where $\bar{R} = (R_d)_i / (R_d)_{max}$ (see Fig.1b).

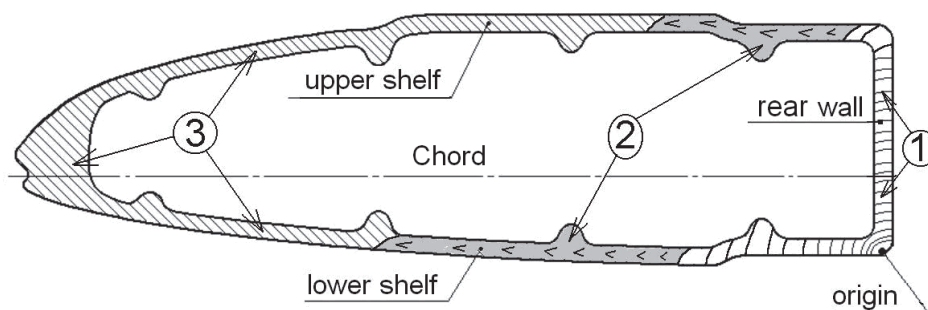
- a fracture-origin exhibits a fracture relief typical of the damage kind and may be located anywhere on the inner or outer surface of the longeron walls;
- a zone (1) of stable crack growth typically exhibits a smooth fracture surface with distinct mesoscopic or macroscopic (depending of the fracture location) beach-marks of fatigue fracture;
- a zone (2) of accelerated crack propagation typically shows a wavy fracture surface of the “Christmas-tree” or “chevron-like” type;

Figure 2: Scheme of longerons fracture surfaces for crack origination from the corrosion pitting with indication “1”-“3” different fracture surface areas.

- a zone (3) of fast crack propagation when the plastic-shear lips form entirely over the wall-thickness of the longeron. In the zone 1, pseudo-striations pattern forms first (P-region), peculiar to low-rate crack growth in the near-threshold range of the kinetic diagram. The material here experiences extensive shear. As the crack length increases, a pattern of fatigue striations forms or, alternatively, mesoscopic fatigue beach-marks dominate, depending on the blade section in that the crack propagates.

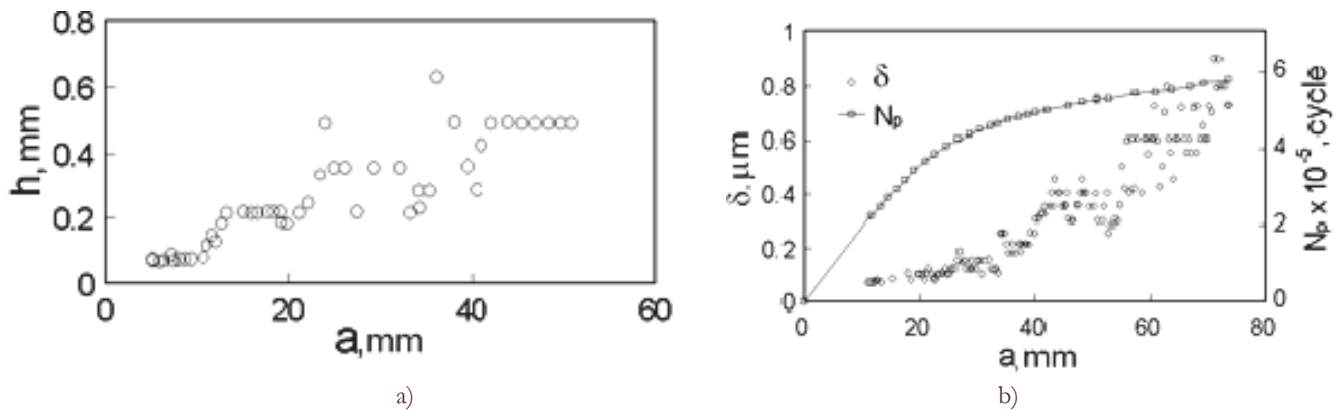
Sequentially measured distances between MBM and, then, between the Macro-Beach-Marks confirmed that there recurrence along the crack path is not casual, but regular, indicative of the very blade-loading patterns, regularly repeated with each single flight cycle, Fig. 3. Therefore, the regularly increasing distances between these marks are indicative of the crack-growth rate regularly increasing from flight to flight. And the number of these beach-marks corresponds to the number of the helicopter flights accomplished with the fatigue crack propagating in the longeron.

Figure 3: Spacing of (a) meso- or macro-beach-marks and (b) fatigue striations with number of cycles N_p against crack length a for two longerons (a) and (b).
